East End of Runway at Brandis Airfield

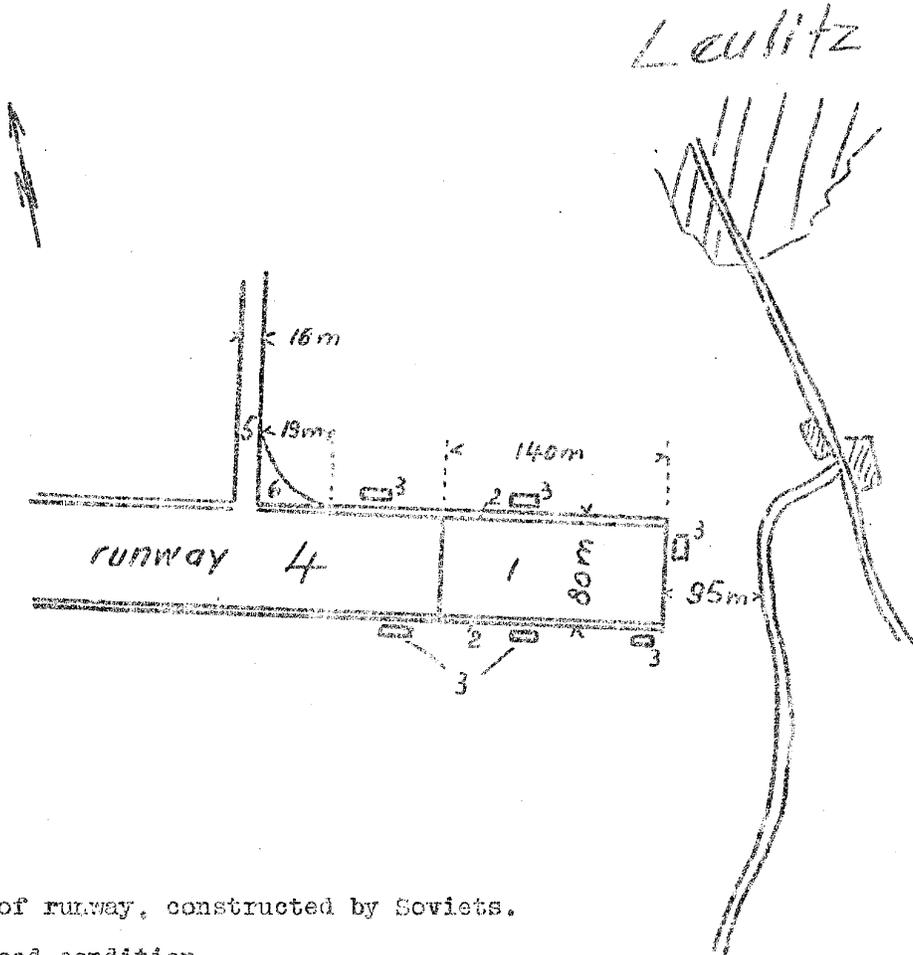
- 1 Extension of runway, constructed by Soviets.
It is in good condition.
- 2 Drainage ditches, about 35 cm wide, partially covered with flat cement stones.
- 3 Cement recesses, each 0.8 x 2.5 meters and covered with three wooden lids.
- 4 Old runway with asphalt cover, constructed in 1945, repaired with cement, in good condition.
- 5 Asphalt taxiway, in good condition.
- 6 Small curve.
